Technical Memorandum

Kainga Ora – Waikowhai

Hand Auger Geotechnical Investigation WK-045 Block
Harrison Grierson

REF: J7425-2
DATE: 1 May 2026

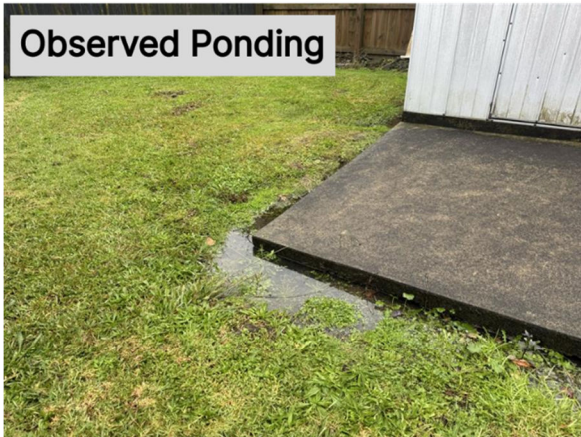
The investigation was undertaken at 1213 Dominion Road, Auckland. At the time of investigation, the site was generally grassed and near level, with existing structures present within the site area. Localised ponding of surface water was observed in some locations following rainfall.

Observed Ponding

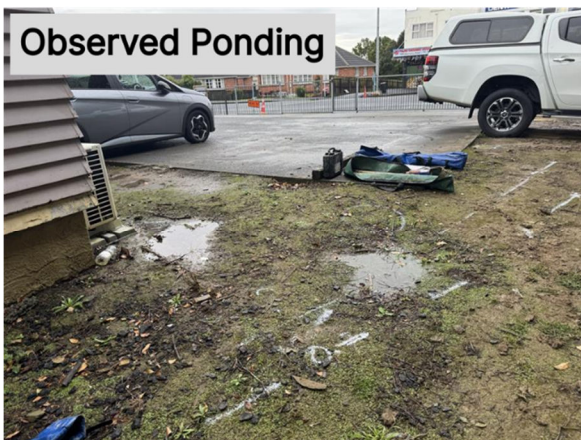
Observed Ponding

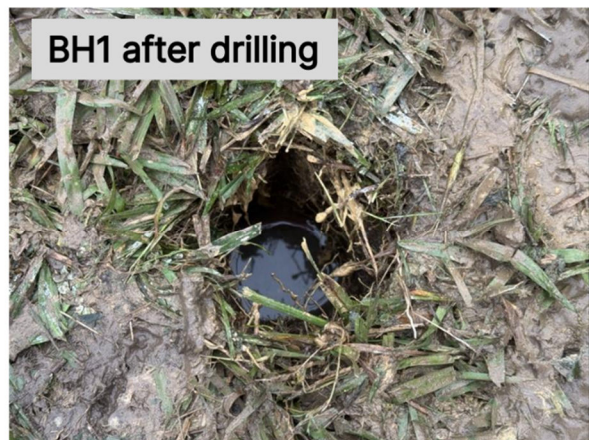
3.4					
		3.6			175		
		3.8			96		
		4.0			137		
		4.2			62		
		4.4					
		4.6					
		4.8					
		5.0					
		5.2					
		5.4					
		5.6					
		5.8					
E.O.B.: 4.00m Target Depth Achieved		Shear Vane No.: 3155	Logged By: VC	Checked By: CL	Observations/Comments: Groundwater unconfirmed. Hole filling up with water after drilling

BH1 after drilling

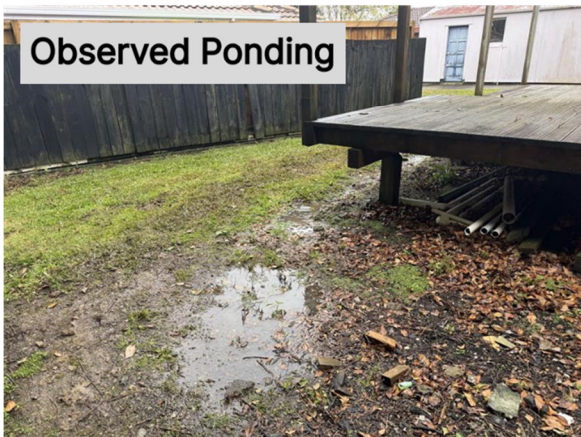
Observed Ponding
