Section Inspection - 5/12/2023 - 849004

Section No. 4	Asset ID 849004	Operator's Reference	Date of inspection 5/12/2023	Time of inspection 9:03 am	Precipitation No precipitation
Town or suburb Onehunga	Name of Coder T. Martin	Name of Operator Adam H	Video volume reference 1 231205	Standard NZPIM (Gravity)-4th Edition 2019	Client Korahi Alliance Limited

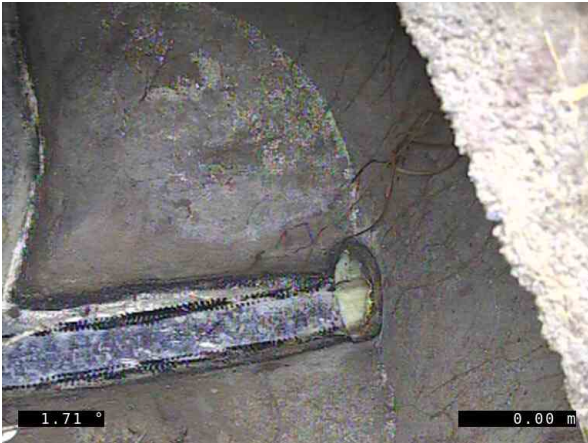
1, 00:00:00, 0.00m (32.06m)
Inspection start, node reference: 517286

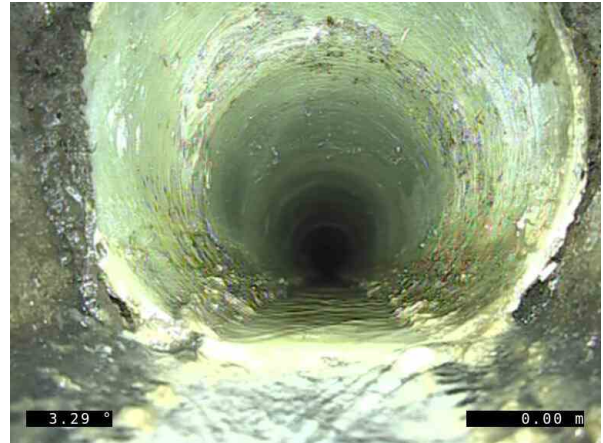
2, 00:00:00, 0.00m (32.06m)
Inspection start, node reference: 517286

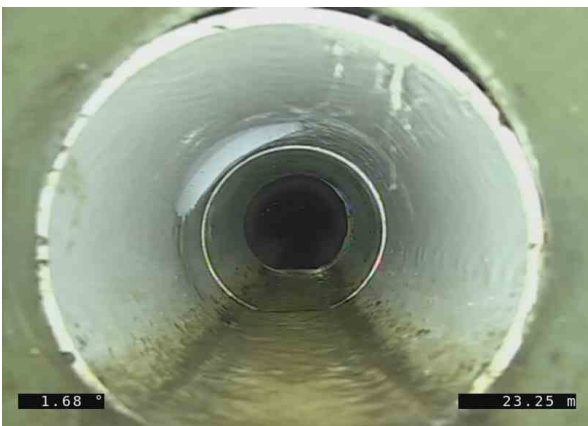
3, 00:04:02, 23.25m (8.81m)
Material change / CIPP to PVC

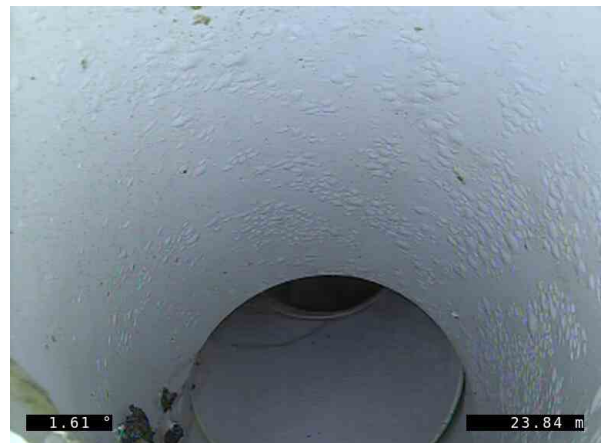
4, 00:04:22, 23.84m (8.22m)
The lateral is open, at 10 o'clock / 100mm

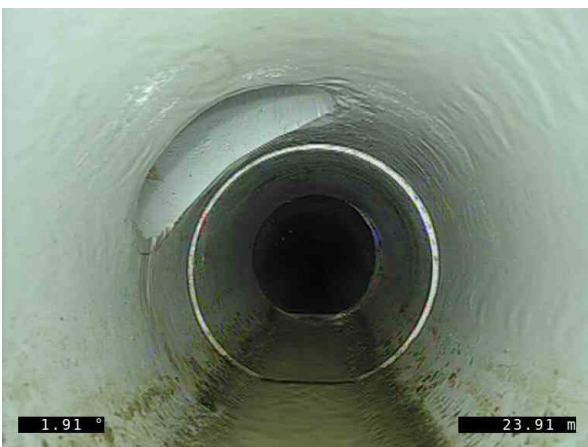
5, 00:04:22, 23.84m (8.22m)
The lateral is open, at 10 o'clock / 100mm

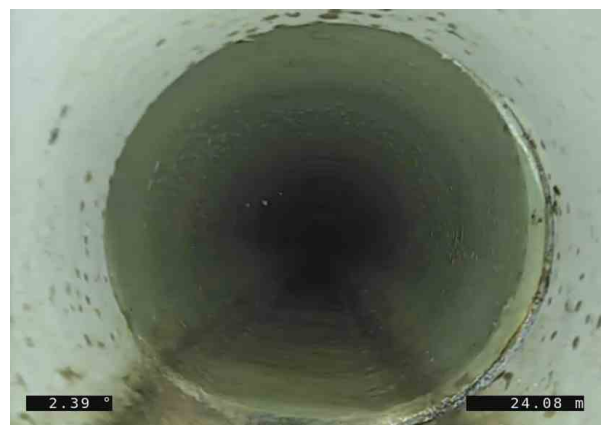
6, 00:04:41, 24.08m (7.98m)
Material change / PVC to CIPP

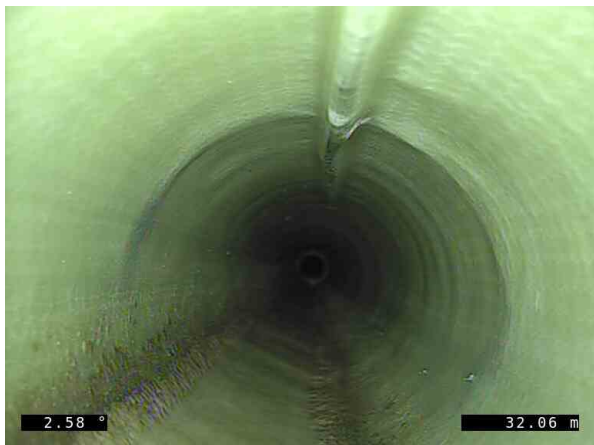
7, 00:07:10, 32.06m (0.00m)

Inspection abandoned / Due to loss of traction 1.4m dti
