Section Pictures - 16/05/2024 - 849005

Town or suburb Oranga	Location ORANGA TOC54	Date of inspection 16/05/2024	Asset ID 849005	Section No. 9
---------------------------------	---------------------------------	---	---------------------------	-------------------------

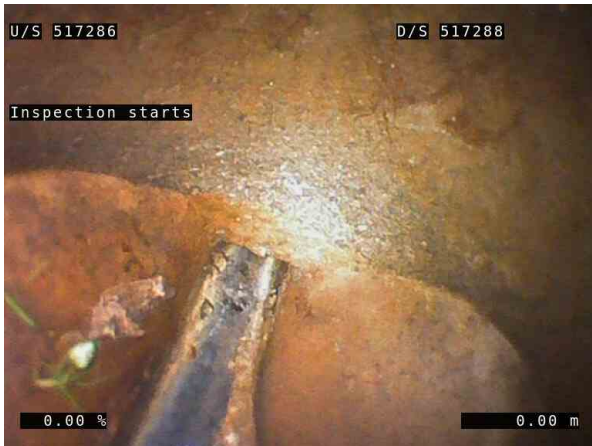
1, 00:00:00, 0.00m (21.00m)
Inspection start, node reference: 517286

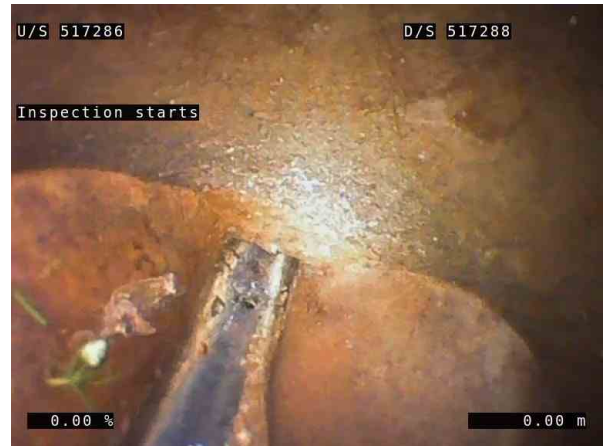
2, 00:00:00, 0.00m (21.00m)
Inspection start, node reference: 517286

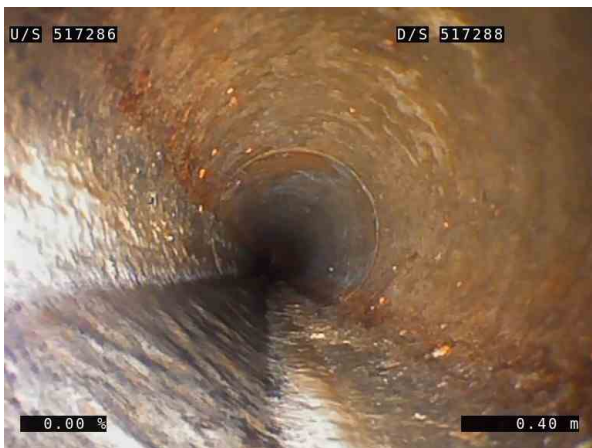
3, 00:00:36, 0.40m (20.60m)
Debris greasy, small, clear diameter is reduced by less than 10% from 4 o'clock to 8 o'clock, start / Pipe walls

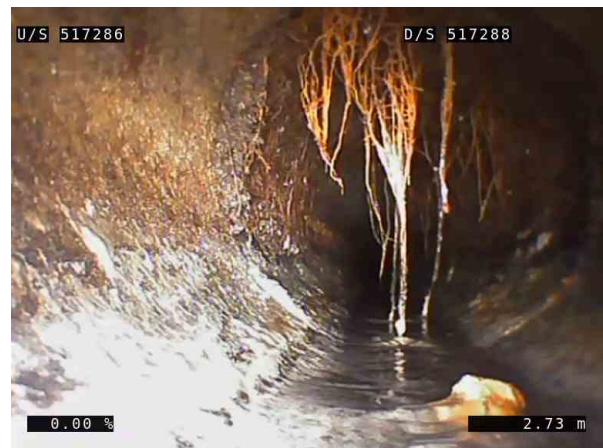
4, 00:01:06, 2.73m (18.27m)
The sealing of the joint is faulty, large, clearly through the pipe wall from 8 o'clock to 4 o'clock / RIFM

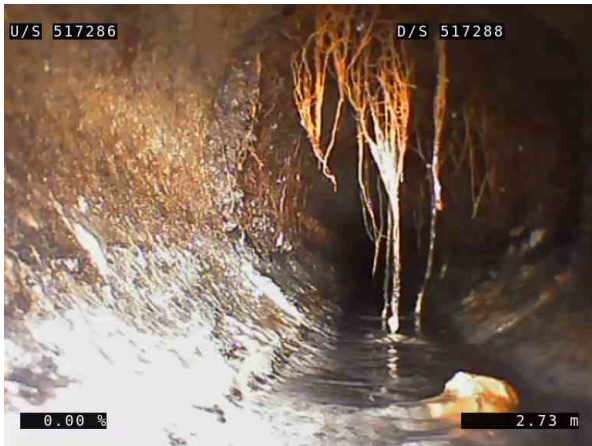
5, 00:01:06, 2.73m (18.27m)
Fine roots, restrict flow by 10% to 25% of full flow from 8 o'clock to 4 o'clock

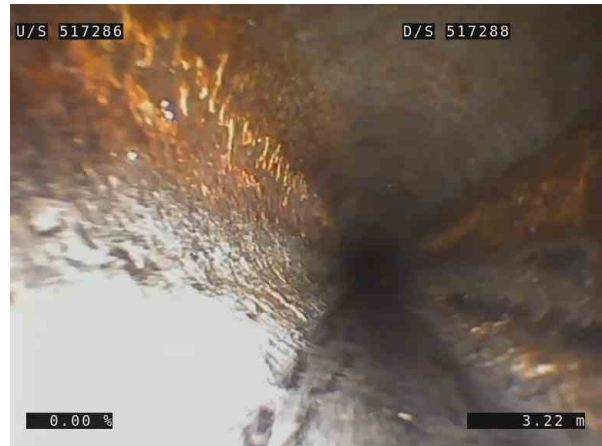
6, 00:01:11, 3.22m (17.78m)
Fine roots, restrict flow by 10% to 25% of full flow from 8 o'clock to 4 o'clock

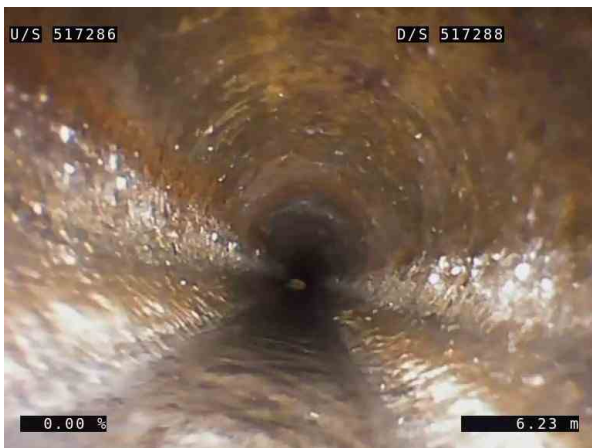
7, 00:01:28, 6.23m (14.77m)
Debris silt, small, clear diameter reduced by less than 10%, start / Gravel mud
