Section Inspection - 16/05/2024 - 849006

Location ORANGA TOC54	Asset ID 849006	Asset owner's Reference	Date of inspection 16/05/2024	Time of inspection 3:55 pm	Precipitation No precipitation
Town or suburb Oranga	Name of Coder John Grieve	Name of Operator R. Pearce	Video volume reference 1 35820	Job Status	Client Korahi Alliance

Pipe Length 46.34 m	Material RC	Use of Pipeline F
Setup Upstream node	Lining type	Purpose of inspection R
Surveyed Length 46.12 m	Lining material	Inspection Currency CI
Joint Spacing 1.80 m	Width 150 mm	Inspection Status IC
Asset owner	Shape C	Cleaning Status NC
Up node reference 538135	Down node reference 517286	
U/S Node Type Sewer Manhole	D/S Node Type Sewer Manhole	
Depth at upstream node	Depth at downstream node	
U/S Location 2 Torokina Place	D/S Location 61 State Avenue	
General comment CCTV inspection for condition

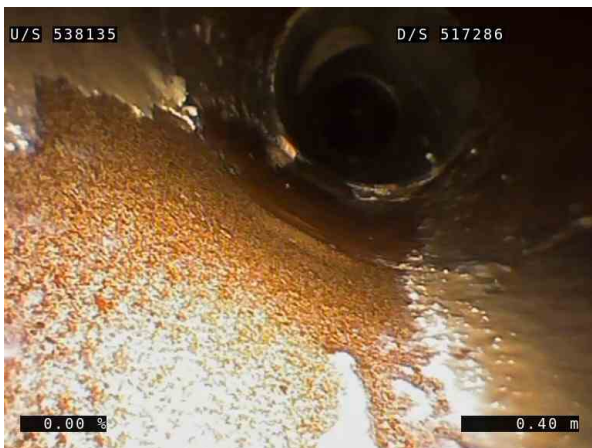
3, 00:00:41, 0.40m (45.94m)
Debris greasy, small, clear diameter is reduced by less than 10% from 12 o'clock to 12 o'clock, start / Fat - Grease

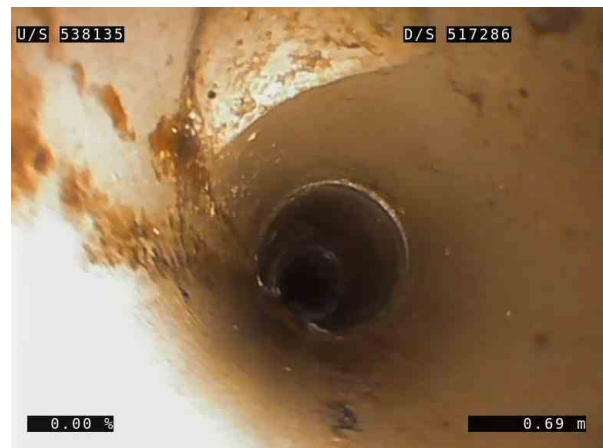
4, 00:00:44, 0.69m (45.65m)
The lateral is open at 9 o'clock / 100mm

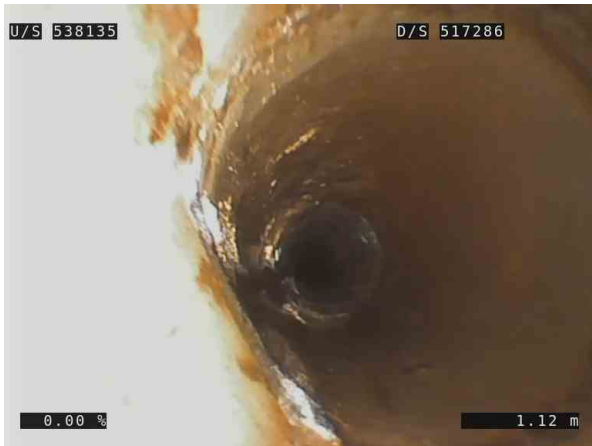
5, 00:00:46, 1.10m (45.24m)
Obstruction permanent, reduction of up to 10% of the pipe diameter from 5 o'clock to 7 o'clock / Grout

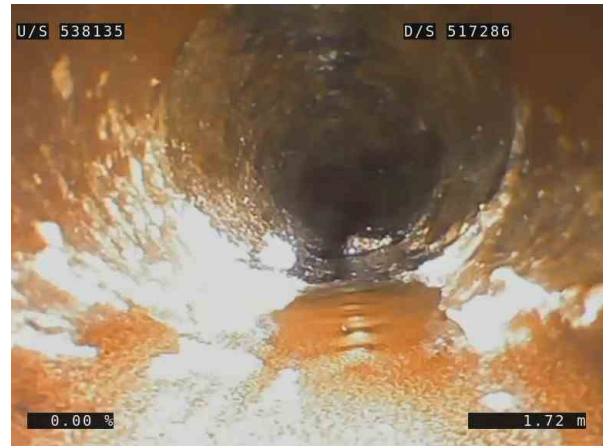
6, 00:00:48, 1.80m (44.54m)
Material change / EW to RC

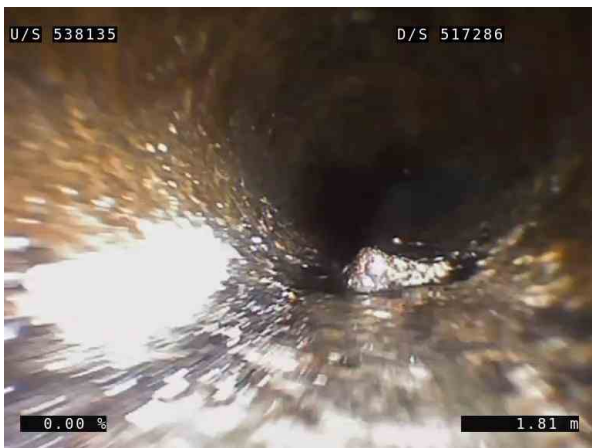
7, 00:00:49, 1.81m (44.53m)
Debris silt, small, clear diameter reduced by less than 10%, start / Gravel stones

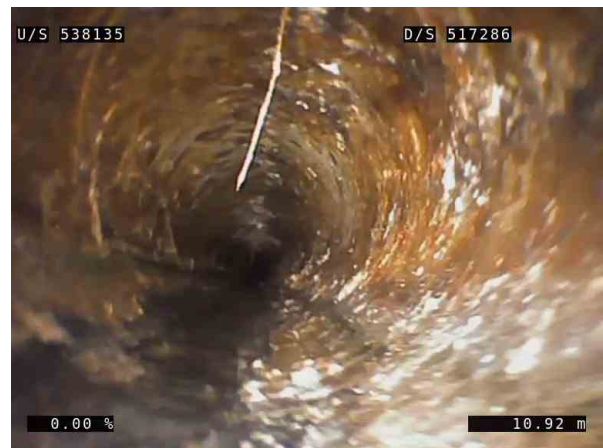
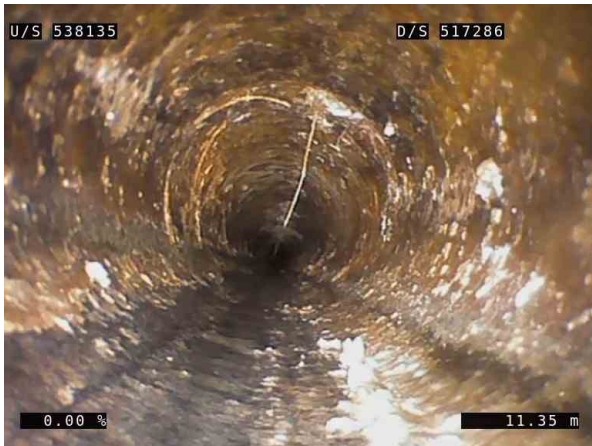
8, 00:01:41, 11.35m (34.99m)
The sealing of the joint is faulty, large, clearly through the pipe wall from 10 o'clock to 12 o'clock / RIFS

9, 00:01:41, 11.35m (34.99m)
The sealing of the joint is faulty, large, clearly through the pipe wall from 10 o'clock to 12 o'clock / RIFS

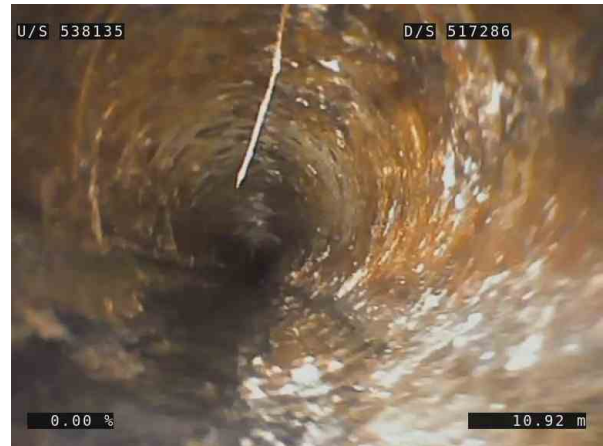
10, 00:01:41, 11.35m (34.99m)
Fine roots, roots restrict flow by 10% or less of full flow from 10 o'clock to 12 o'clock

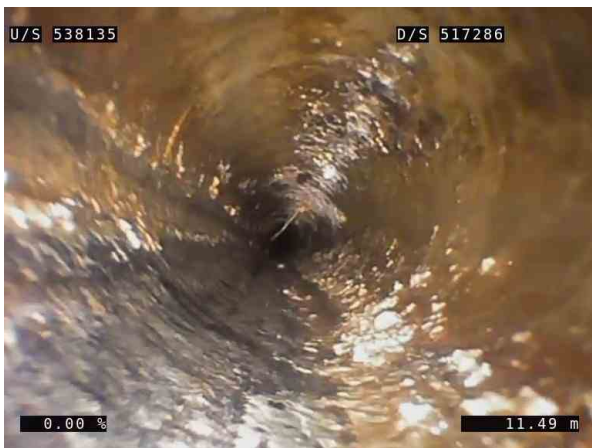
11, 00:01:53, 11.49m (34.85m)
Debris greasy, small, clear diameter is reduced by less than 10% from 10 o'clock to 2 o'clock, start / Pipe roof

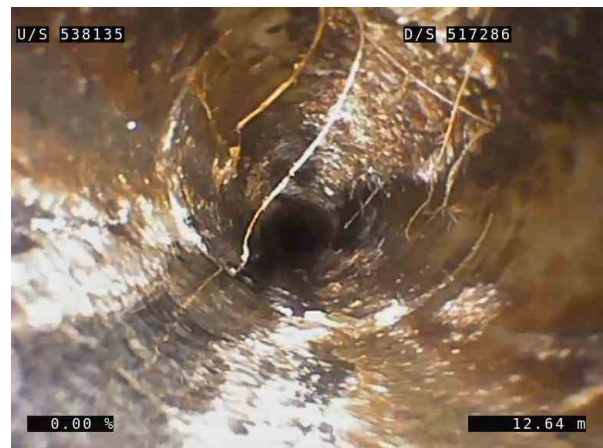
12, 00:01:58, 12.64m (33.70m)
The sealing of the joint is faulty, large, clearly through the pipe wall from 9 o'clock to 2 o'clock / RIFS

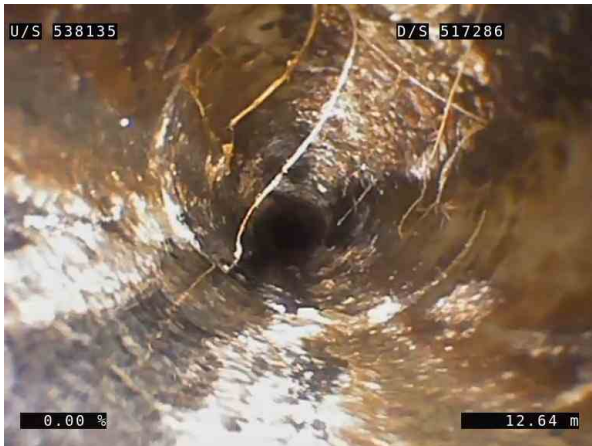
13, 00:01:58, 12.64m (33.70m)
Fine roots, roots restrict flow by 10% or less of full flow from 9 o'clock to 2 o'clock

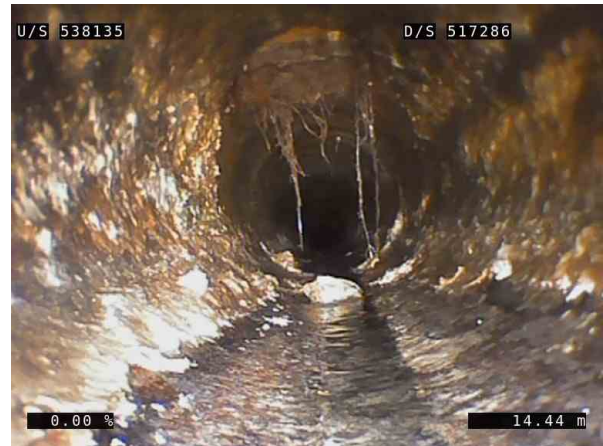
14, 00:02:22, 14.44m (31.90m)
Lateral sealing faulty, evidence exist that the connection between the lateral and the main pipe is leaking at 12 o'clock / 100mm. Roots via seal

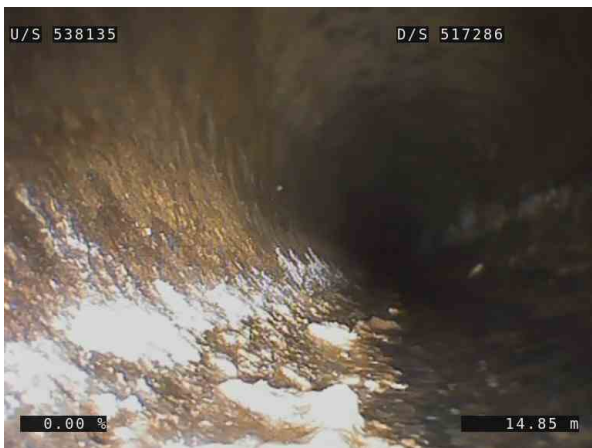
15, 00:02:30, 14.85m (31.49m)
Fine roots, roots restrict flow by 10% or less of full flow from 9 o'clock to 2 o'clock

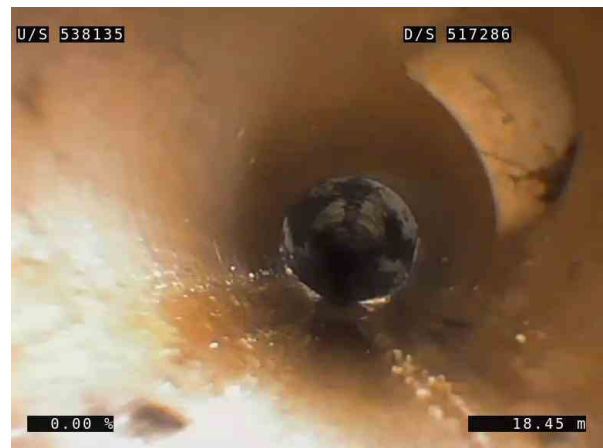
16, 00:03:00, 18.45m (27.89m)
Material change / RC to VC

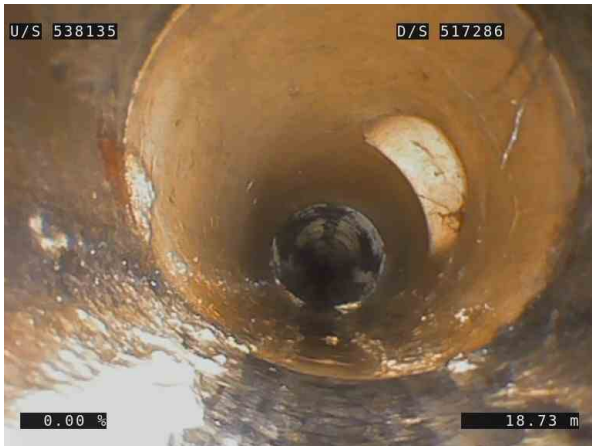
17, 00:03:08, 18.45m (27.89m)
The sealing of the joint is faulty, large, clearly through the pipe wall from 2 o'clock to 5 o'clock / RIFS

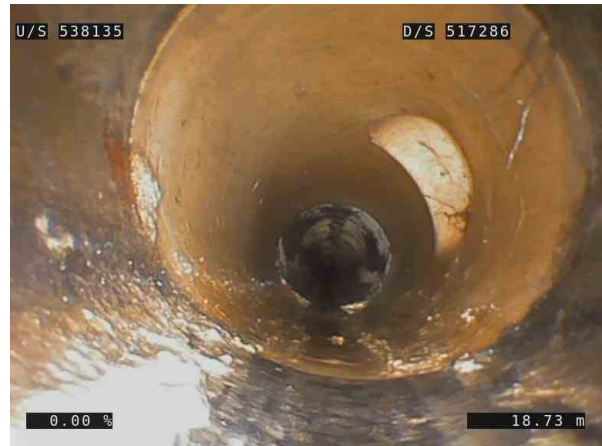
18, 00:03:08, 18.45m (27.89m)
Fine roots, roots restrict flow by 10% or less of full flow from 2 o'clock to 5 o'clock

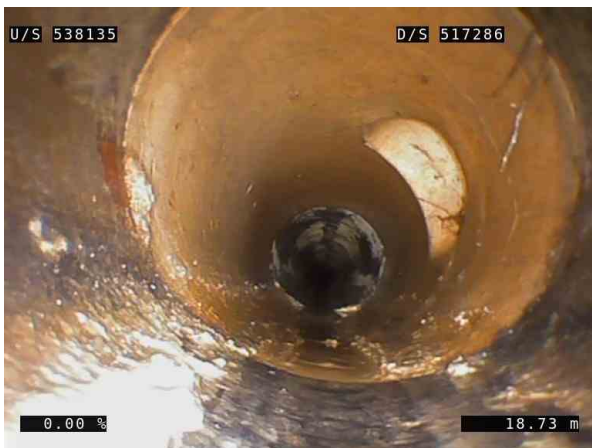
19, 00:03:07, 18.73m (27.61m)
The lateral is open at 2 o'clock / 100mm

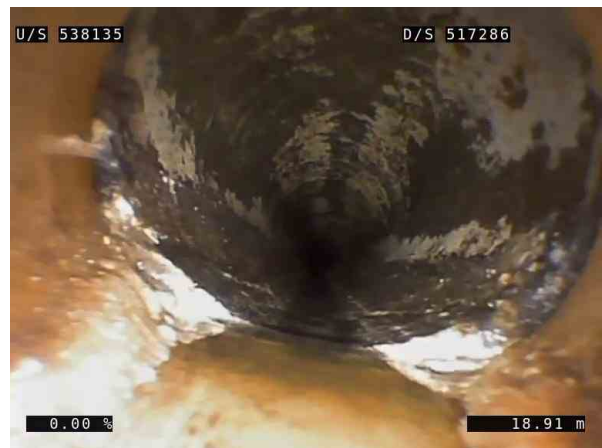
20, 00:03:15, 18.91m (27.43m)
Material change / VC to RC

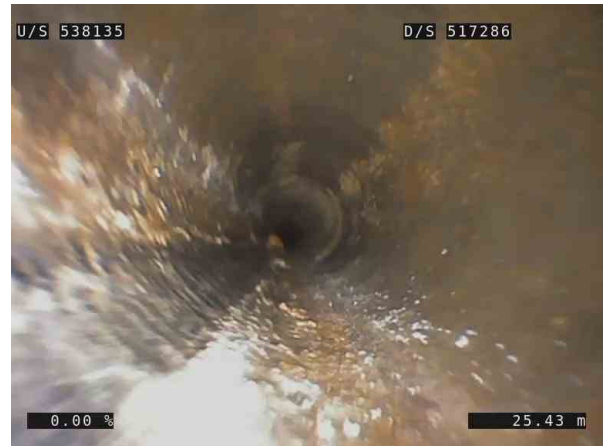
22, 00:03:48, 25.43m (20.91m)
Debris greasy, small, clear diameter is reduced by less than 10% from 10 o'clock to 2 o'clock, end / Pipe roof

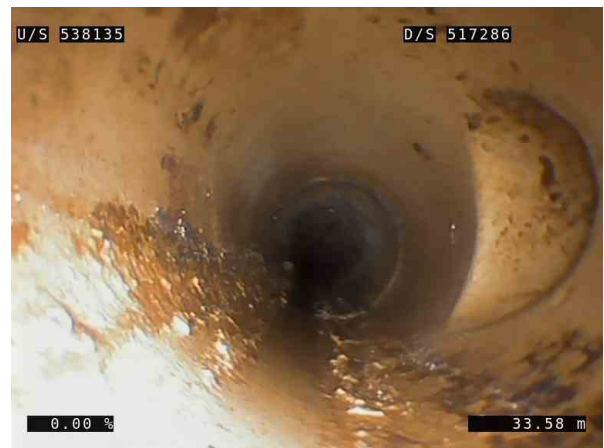
24, 00:04:37, 33.58m (12.76m)
Material change / RC to VC

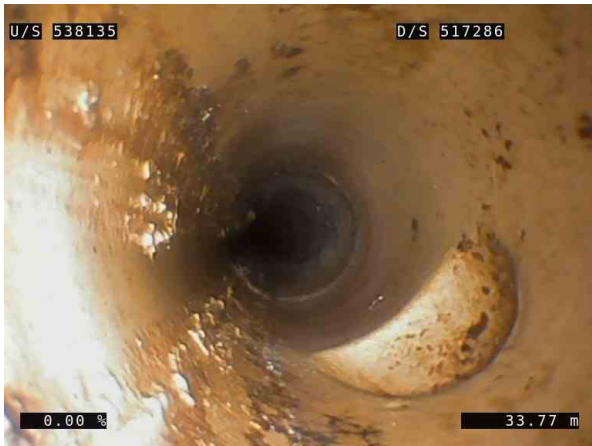
25, 00:04:44, 33.77m (12.57m)
The lateral is open at 2 o'clock / 100mm

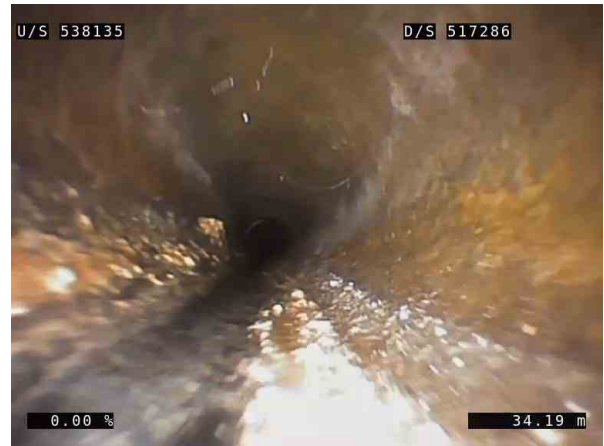
26, 00:04:51, 34.19m (12.15m)
Material change / VC to RC

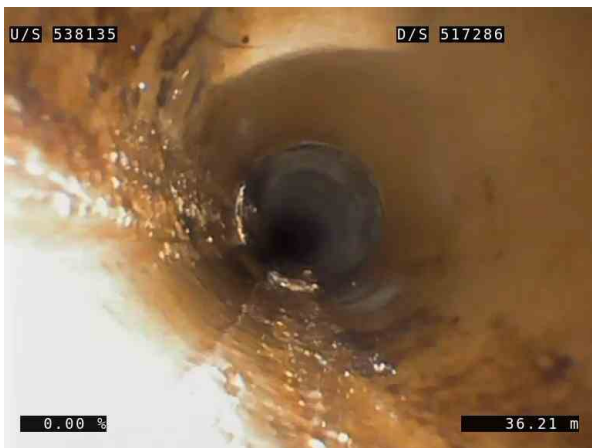
27, 00:05:11, 36.20m (10.14m)
Material change / RC to VC

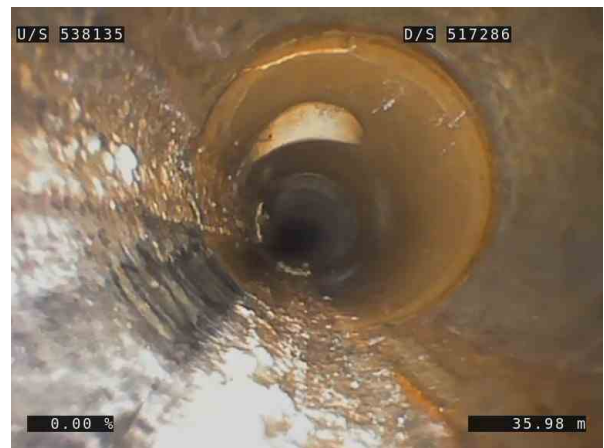
28, 00:05:09, 36.21m (10.13m)
Joint faulty, medium cracking or spalling, probably through the pipe wall from 7 o'clock to 12 o'clock

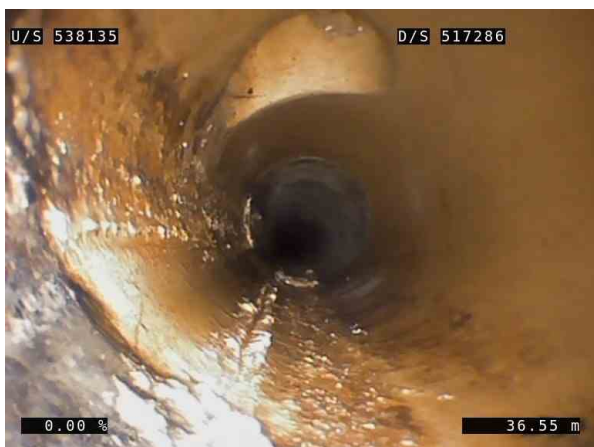
29, 00:05:18, 36.55m (9.79m)
The lateral is open at 9 o'clock / 100mm

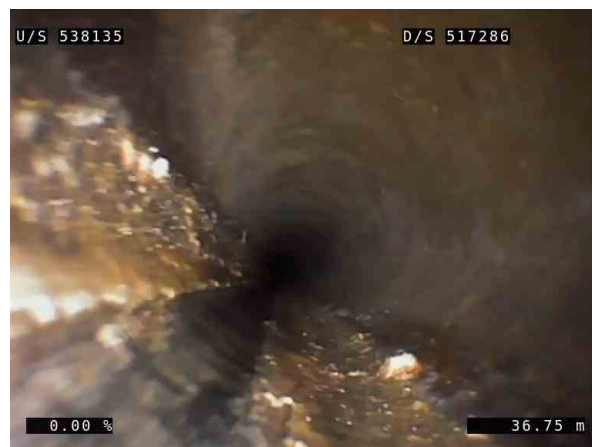
30, 00:05:25, 36.75m (9.59m)
Material change / VC to RC

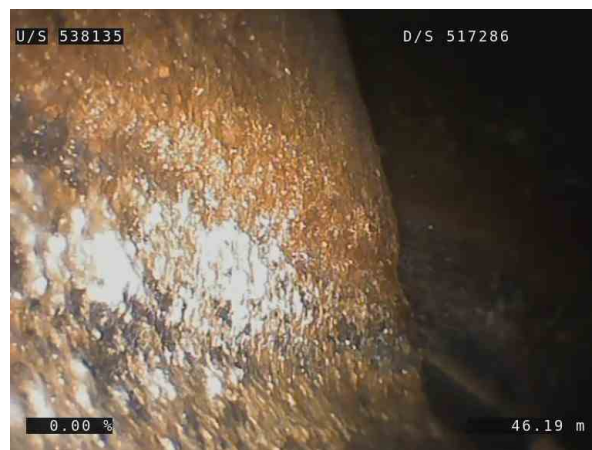
32, 00:07:15, 46.19m (0.15m)
Debris silt, small, clear diameter reduced by less than 10%,
end / Gravel stones

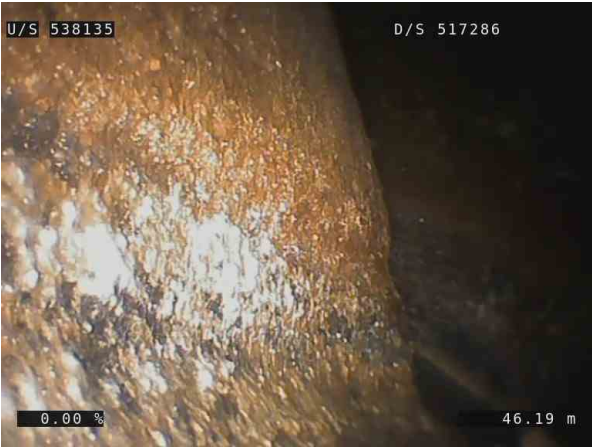
33, 00:07:15, 46.19m (0.15m)
Debris greasy, small, clear diameter is reduced by less than 10% from 4 o'clock to 8 o'clock, end / Pipe walls
