MANGERE WEST STAGE 1

Superlot MW-A17

Geotechnical Completion Report

MANGERE WEST STAGE 1– SUPERLOT MW-A17 – GEOTECHNICAL COMPLETION REPORT

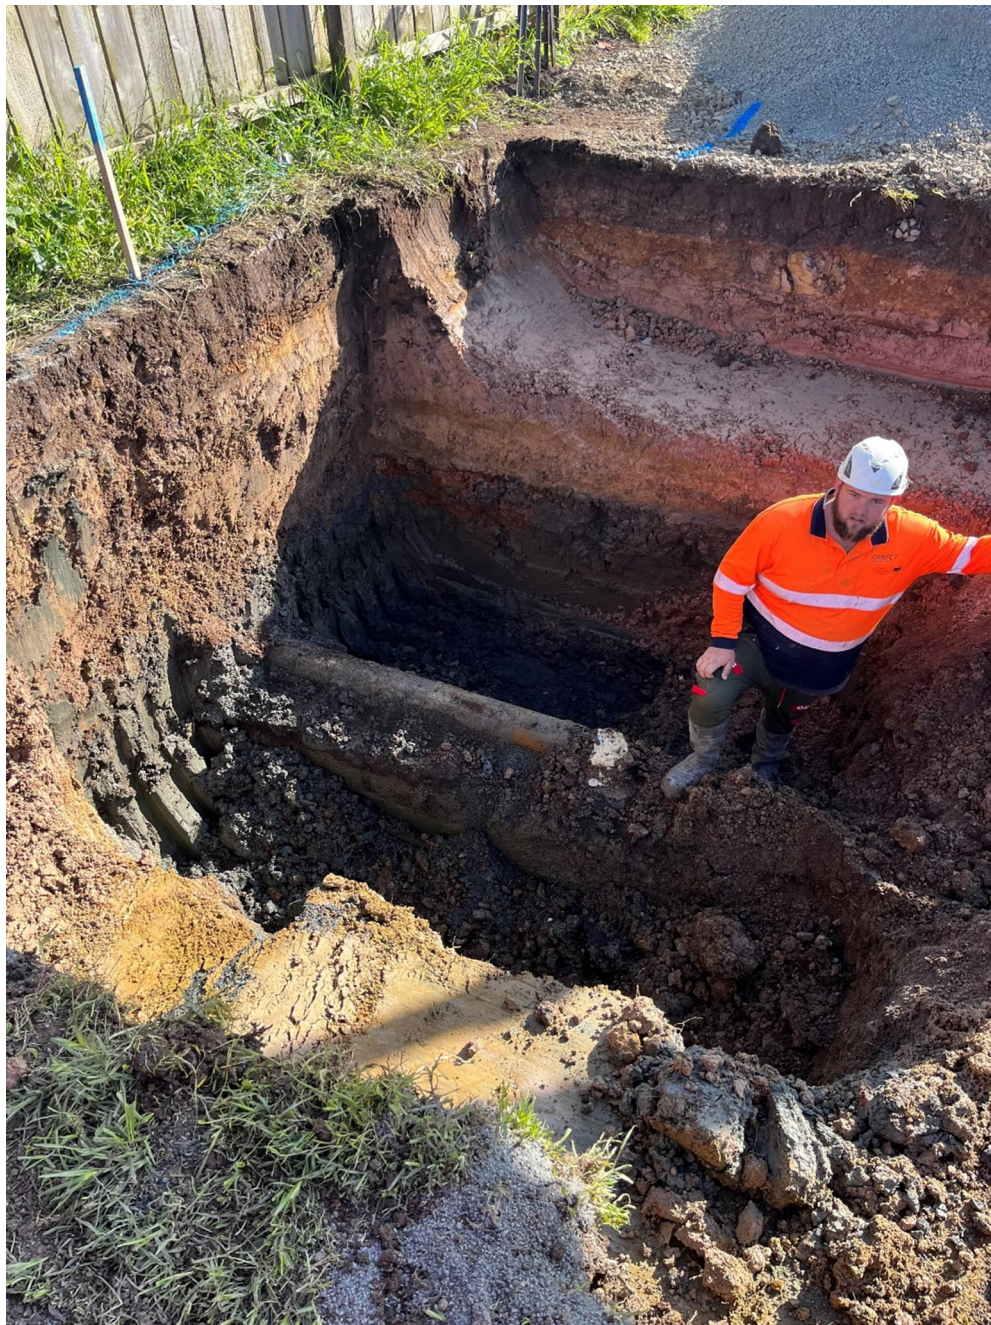
<p>Observations:</p> <p>A Piritahi Geotechnical Engineer visited site to observe the ground conditions for wastewater manhole A1 (WWMH A1). The ground conditions observed from the sides of the trench from ground level to approximately 1.3m depth comprise orange-brown volcanic ash silt/clay. From approximately 1.3 m depth to the base of the excavation, grey to dark grey Tauranga Group silt/clay was observed.</p> <p>Shear vanes were undertaken at the base of the excavation, resulting in undrained shear strength readings of 120 kPa to 145 kPa.</p> <p>As the per the Wastewater ITP for manhole subgrade with shear strengths greater than 80 kPa, no undercut is required.</p> <p>Groundwater was seen ponding at the base of the excavation. It was discussed with the construction team that this water and any loose material be removed from the excavation prior to the laying of hardfill. The construction team shall ensure that the backfill of the undercut and material surrounding the new pipe and manholes shall be maximum 200mm thick compacted thickness per layer and tested using Clegg hammer (or shear vanes for cohesive upper fill).</p>

Photograph 1: Location of WWMH A-1.

<p>Agreements/recommendations onsite:</p> <ul style="list-style-type: none"> - Base of excavation to be cleaned of any loose material and debris prior to manhole installation. - Construction team to ensure backfilled layers are 200mm thick maximum and tested with Clegg hammer (or shear vane for cohesive upper backfill layers), in accordance with the wastewater ITP. - Backfill test record sheets to be reviewed by CPS for completeness and compliance with the ITP. 	
<p>Follow-ups and further actions required:</p> <ul style="list-style-type: none"> - CPS to follow up on compaction testing QA for the manhole and the wastewater line once constructed

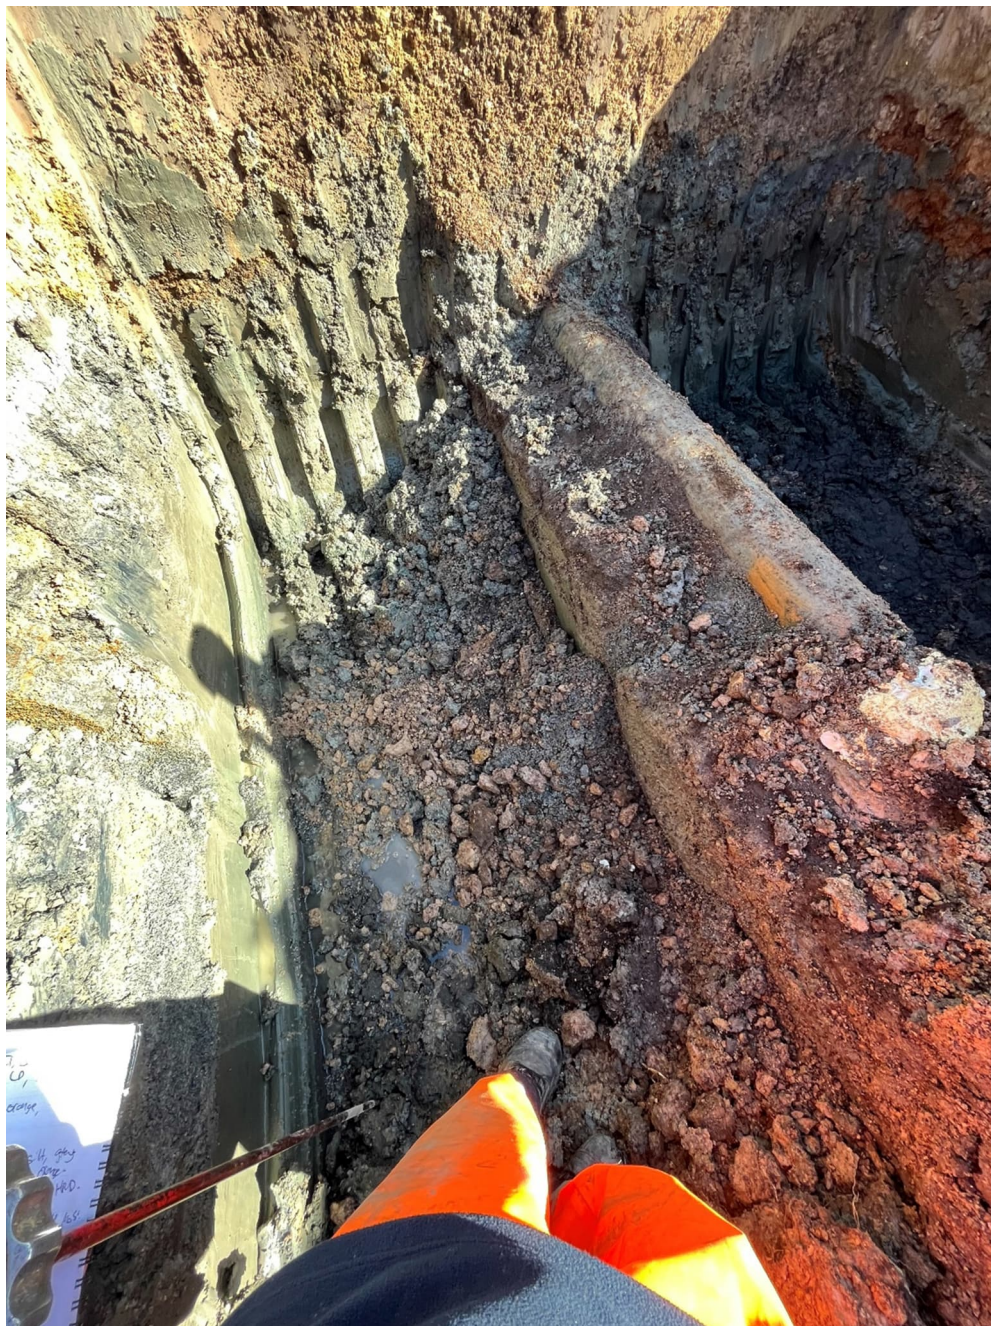
Photograph 2: Ground conditions at location of WWMH-A1.

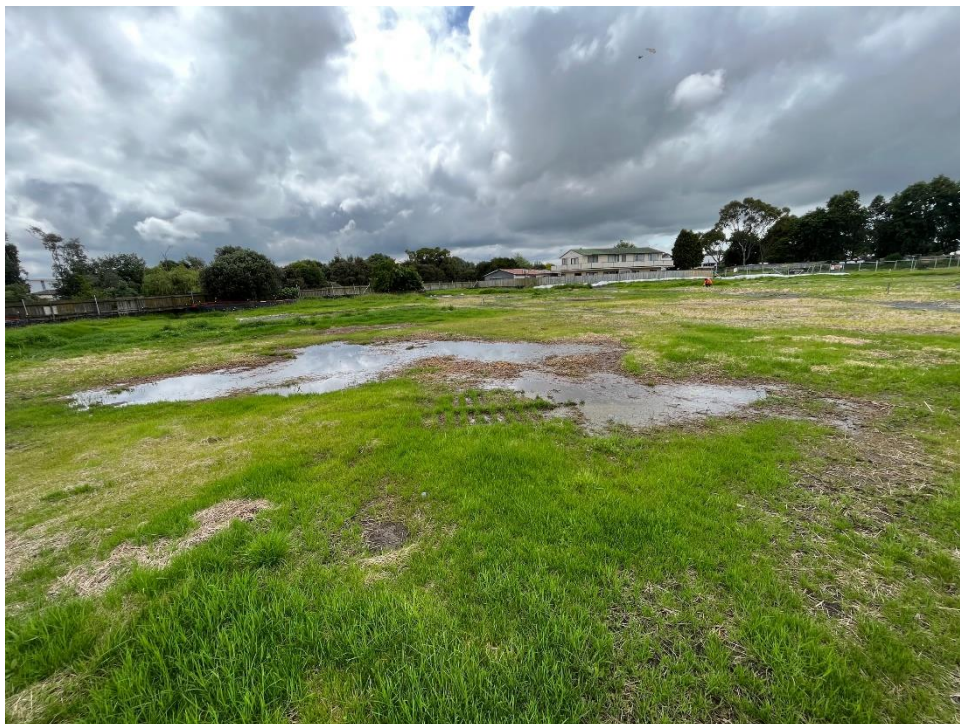
Photograph 3: Water pond near the centre of the superlot
