MANGERE WEST STAGE 1

Superlot MW-A17

Geotechnical Completion Report

MANGERE WEST STAGE 1– SUPERLOT MW-A17 – GEOTECHNICAL COMPLETION REPORT

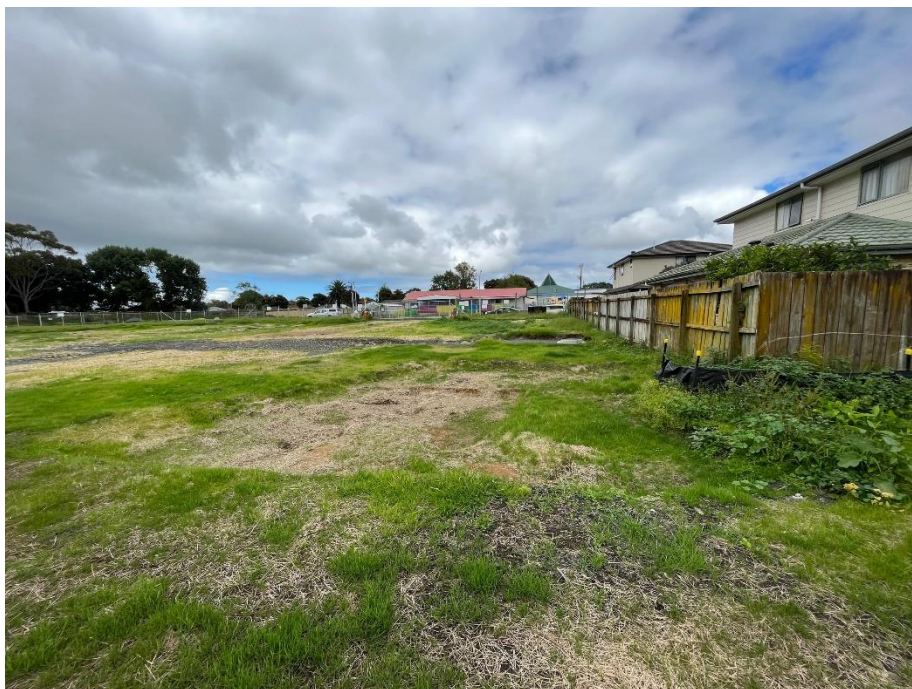
Photograph 1: Superlot overview – looking south west

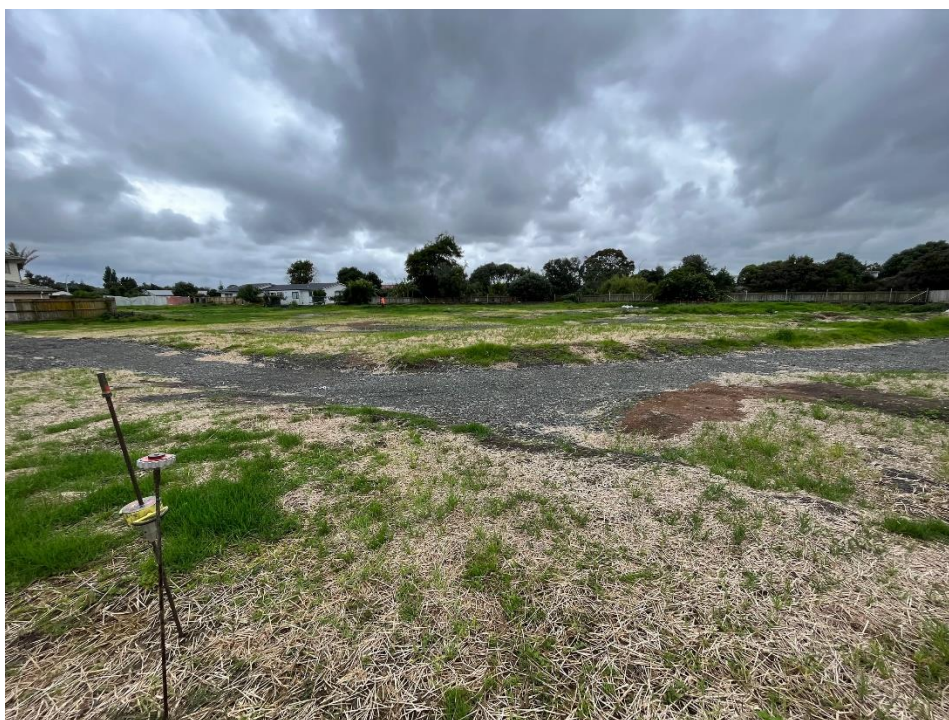
Photograph 2: Superlot overview – looking north
